**OHIO EPA
TIME-CRITICAL REMOVAL ACTION
REFERRAL PACKAGE**

A. Site Name: Former Plastech Engineered Products, Inc. – Andover Facility

B. Location:
205 Maple Street Extension
Andover, OH 44003
Ashtabula County
Latitude/Longitude: N 41.612554° / W 80.568407°
Parcel ID numbers: 020132000300, 020132000700 and 020132000701
EPA ID number: OHD068896778

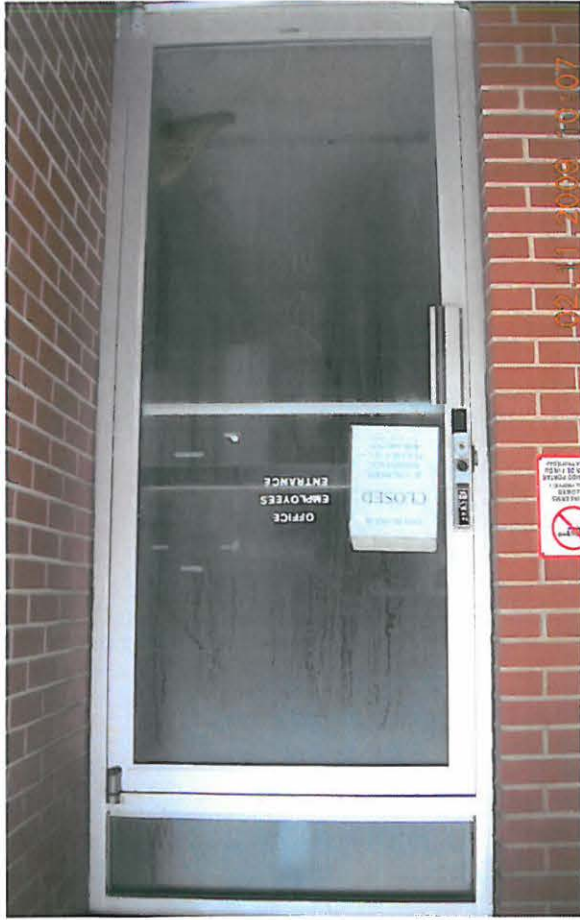
1

Ohio EPA Photograph Log Former Plastech-Andover Facility February 11, 2009 All digital photographs taken and logged by Frank Zingales. DHWM Digital Camera #5 - Nikon Coolpix 5600		
Photo #	Area	Description
1&2	West Side- Office	View of sign on door to Office area of facility.
3&4	Southeast corner/South side of property	Perspective of wood pallets and plastic packaging.
5	West side	View of front of facility.
